Issue Number:	N172404	PDF Date Submitted	01/07/2005

<input checked="" type="checkbox"/> Part - Location:	Ignition Key Cylinder Assembly -Column - Steering				
<input checked="" type="checkbox"/> Complaint:	vehicle can be keyed off with knee while driving				
Issue Type:	Current Prod	Vehicle/Product Line:	3Acar		Region:
<input checked="" type="checkbox"/> Severity:	3	Primary Metric/Score:	LaunchX / 0.025

Primary Project No:	Cobalt	Model Year:	2005
Other Project No(s):	05X001	Model Year Qtr:	
Vehicle/Prop. #:		Model Code:	
Marketing Division:	Chevrolet, Pontiac	Hardware Stage:	
Marketing Region(s):		(VIN) Vehicle ID #:	
Engine(s):		Transmission(s):	
Engine Serial #:		Transmission Serial #:	
Drive Type(s):		Option(s):	
Steering:		PIMREP No:

GMX001 Lock Module Detent in RUN

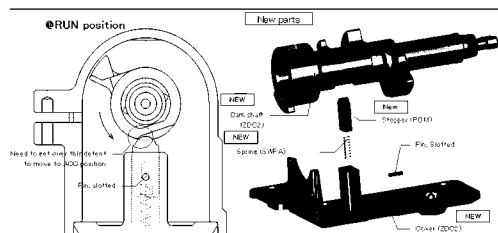
➤ Detent between lock cover and cam shaft:

- ✓ Partial solution based on engineering judgment. No experimental verification that detent is sufficient.
- ✓ If chosen, will drive changes and tuning efforts in ignition switch in order to avoid double detent feel.
- ✓ Design has to become common between Delta, Theta and Kappa
- ✓ Can be combined with the new ignition switch presently sourced for GMT191/2/3 for better detent
